STODDARD TOWN HALL HISTORICAL ASSESSMENT

May 16, 2008
by Eric Lewtas/Architect

Daniel V. Scully/Architects
17 Elm Street
Keene, New Hampshire

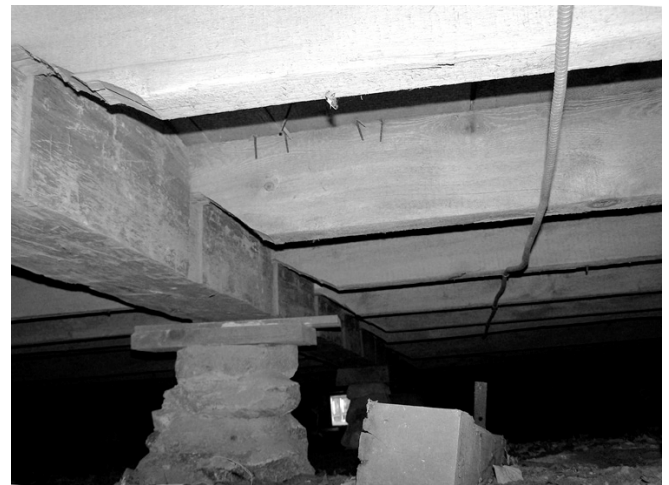
The visible portion of the frame at the south end of the building indicates the frame including the steeple was all built at the same time and has not been altered. This is consistent with historical documentation and early photographs of the building.

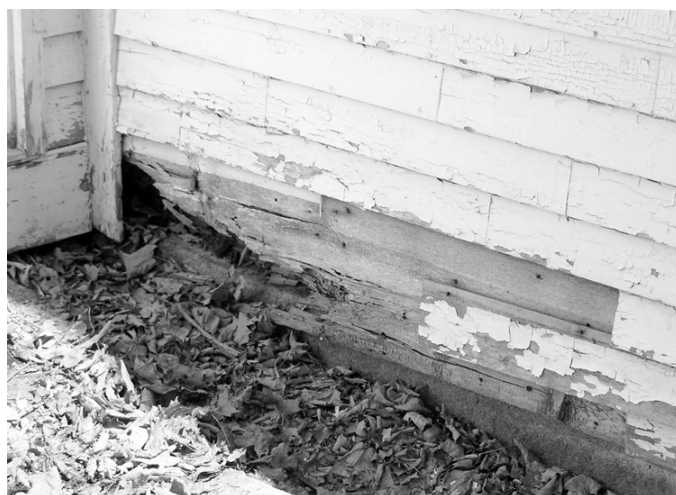
1.A Sill

The one spot where deterioration is visible is the wall sill on the west wall south of the addition. A section several feet long of the clapboard, sheathing and sill are deteriorated right through, due to snow being held against the building above the foundation.

There is a section of framing sill on the west side that is seriously deteriorated. This should be repaired and stabilized immediately. If the sill, sheathing and clapboards are not repaired it will continue to be a route for moisture into the surrounding fabric of the building. If the sill settles in this area, the floor and wall framing will subside, causing distortion in the wall and a low point in the roof. This will cause more water to concentrate and run-off at that point, causing more deterioration at the sill. This condition is the result of the grade being too close to the sill and the accumulation of snow in the corner.

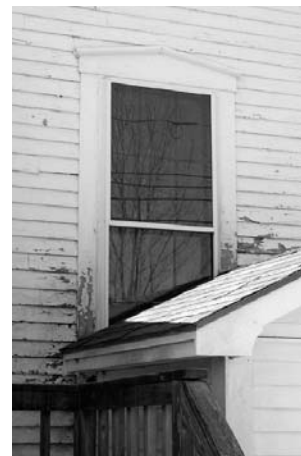
1.B Oil Tank Shed

This shed is build with its roof against a window of the building. The small space left between the roof and the window is a perfect pocket for holding snow and ice, that is always being melted by the heat of building, thereby ensuring a perpetually wet condition. When not full of snow and ice, it funnels run-off from the roofs into the wall. This shed must be removed, there is no way to make this arrangement work. It is expected that the wall of the building and the window will require restoration when this is done.

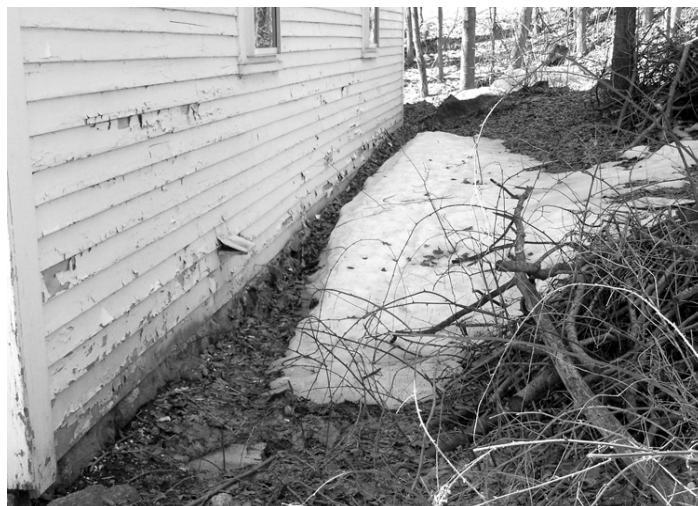
1.C Grades and Vegetation

Over time grades usually rise around buildings. The grade around the north side and north west corner has become too close to the sills of the building, especially on the north side. It must be lowered to at least 8" below the sills, preferably a foot, and kept clear of leaves and debris.

Also the trees and other vegetation around the north and west sides of the building should be significantly thinned and cut back. This overgrowth keeps the building in more shade than ever before, which increases the ground snow build-up amounts and duration (note cover photograph). This increases frost action and promotes dampness by retarding drying. Roots also permeate the soil more than they did historically.
